Manhole Inspection Summary

Manhole # S39E__025MH

Insp Date: **8/20/08 1:46 PM**

Location Address: **901 e fayette st**

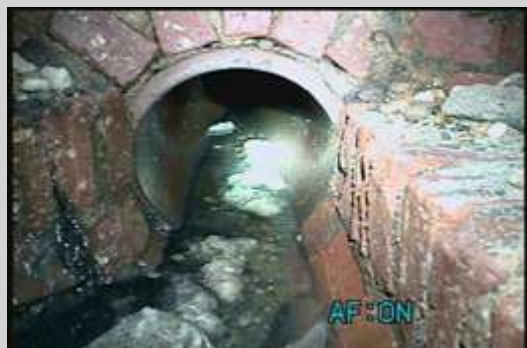
12 O'Clock Outflow

8 in. Circular Gravity Sewer
Pipe Out @ 12 O'Clock

Pipe Material: **Clay** ☐ Pipe Lined

Invert Depth: 11.10 (ft.) Flow Characteristics: **Slow**

Deposits: ☒ None ☐ Mud ☐ Sludge ☐ Debris ☐ Grease

Infiltration: **None** Pipe Seal Cond: **Unknown**

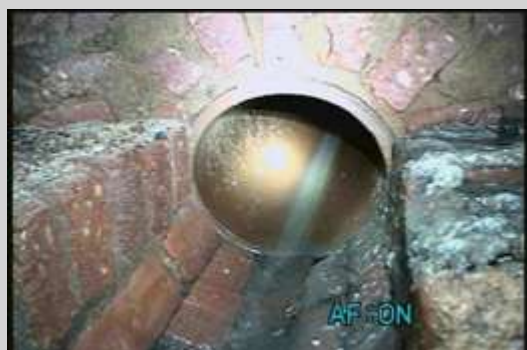
6 O'Clock Inflow

8 in. Circular Gravity Sewer
Pipe In @ 6 O'Clock

Pipe Material: **Clay** ☐ Pipe Lined

Infiltration: **None** Pipe Seal Cond: **Unknown**
